Field Assessment of Construction Components for Wetland Restorations

Minnesota Board of Water and Soil Resources

This report has been prepared for the USDA Natural Resources Conservation Service by the Minnesota Board of Water and Soil Resources (BWSR) as part of a contribution agreement between the agencies (#68-6322-12-0-10).
Prepared by Carol Strojny, Terry Ragan, P.E., and Tom Wenzel, P.E.,

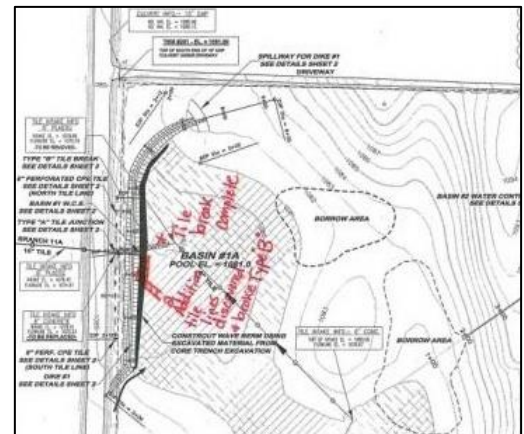
Portion of an as-built plan map.

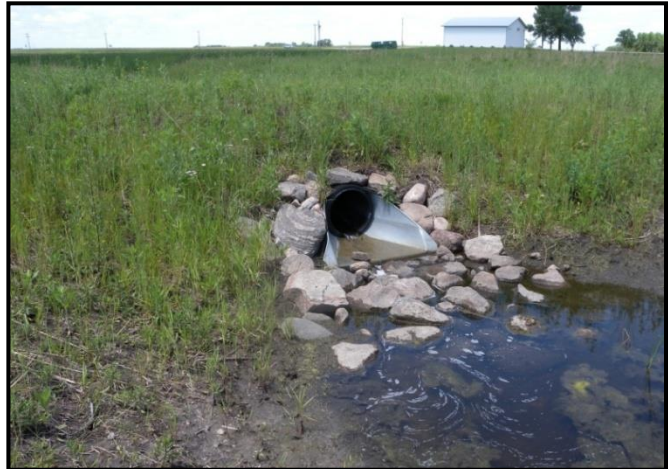
Pipe from a wetland's outlet structure that is well armored and appears to be in good condition.

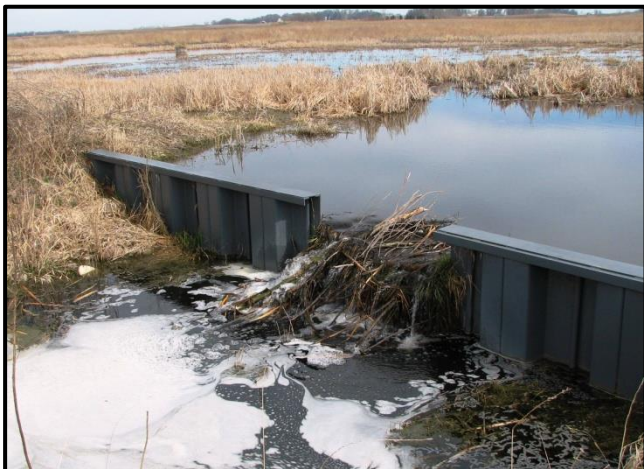
Beaver have plugged the opening of weir structure that is used to control wetland water discharges and water levels.

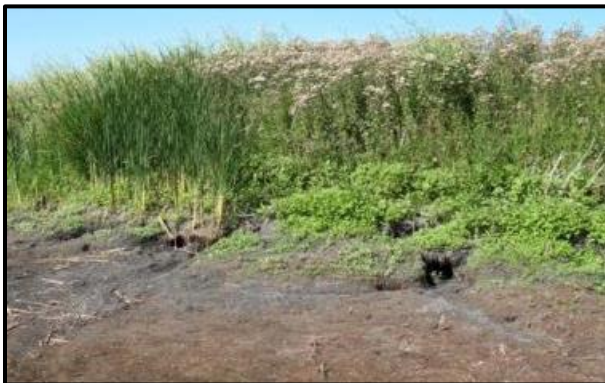
An embankment with moderate to severe muskrat damage. Photo was taken during a dry or drawdown period. Repair is likely necessary (condition score 3).

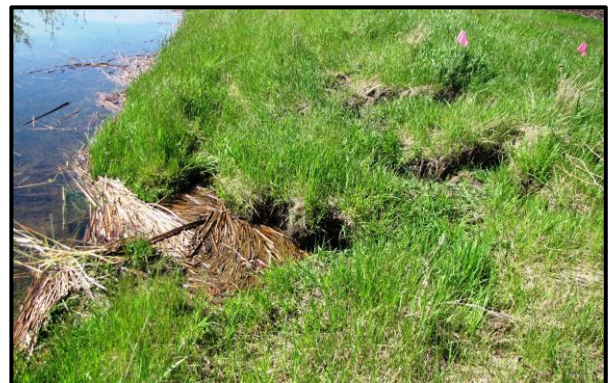
Significant muskrat damage within an embankment. Repair is necessary – condition score 4.

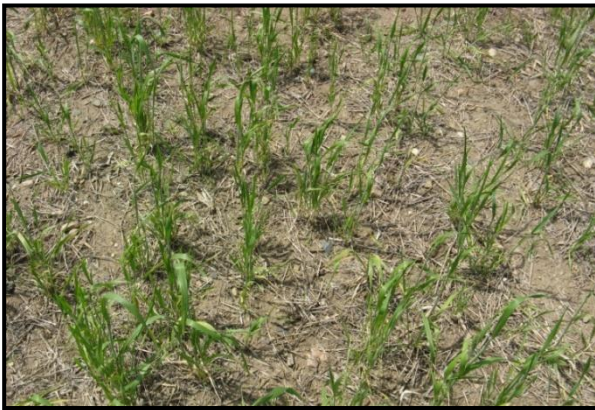
Poor stand of grass on embankment. It needs to be re-seeded - condition score 2.

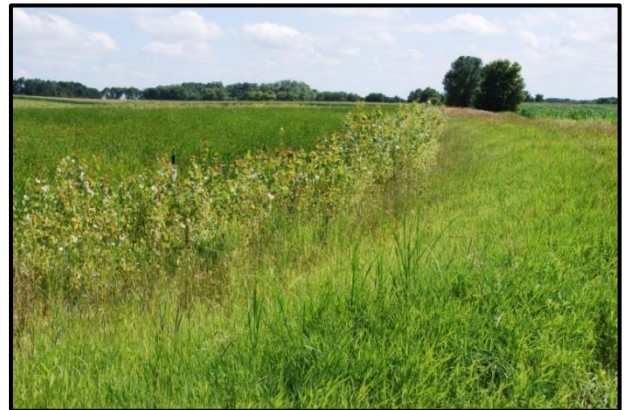
Cottonwood trees growing on upstream embankment slope toe. Maintenance is required - condition score 3.

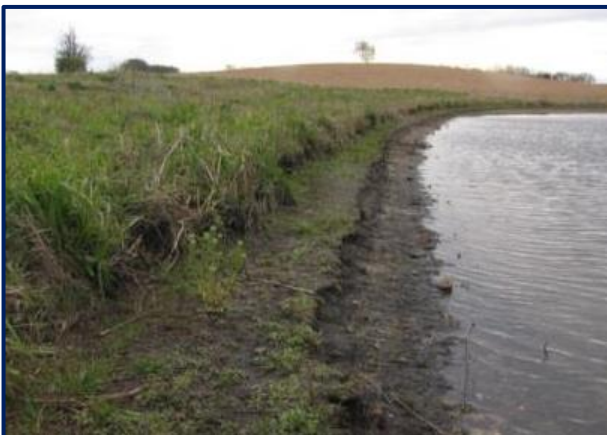
Moderate to severe embankment damage from wave action. Repair may be necessary - condition score 3.

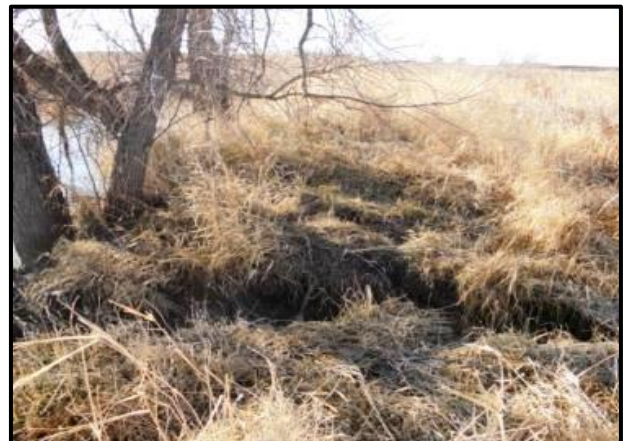
Mature cottonwood trees growing on embankment. Note erosion of embankment soils due to tree roots. Tree removal and embankment repair - condition score 4.

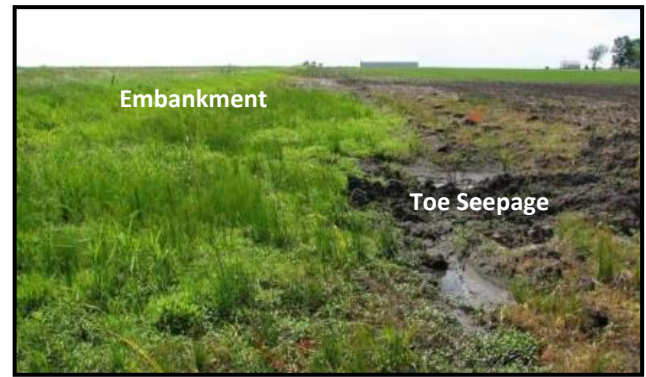
Seepage issue on downstream toe of embankment. Note standing water on downstream cropland. Repair is necessary - condition score 4.

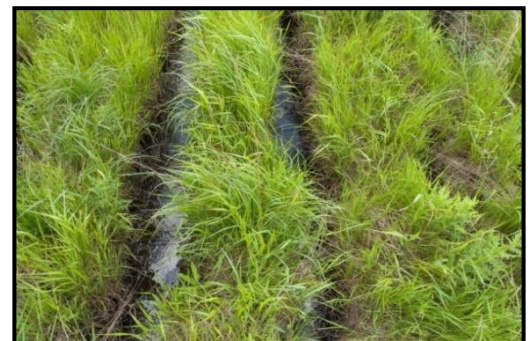
Deep ruts on embankment surface caused by excessive ATV use. Repair is likely needed – condition score 3.

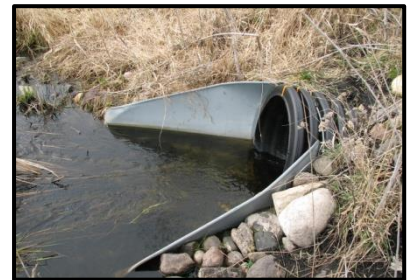
Entrance to a horizontal culvert through an embankment.

Horizontal pipe culverts are simple outlet structures used to control outflows and maintain wetland water levels. Culverts can be a variety of sizes, materials, and lengths depending upon the design needs of a project.

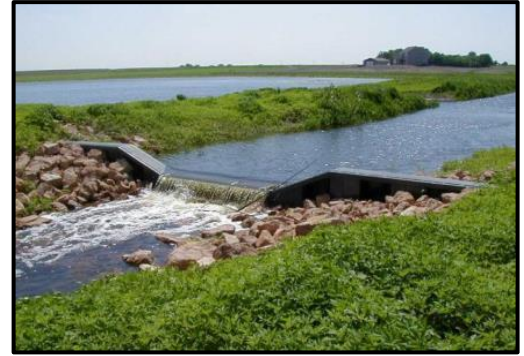
Steel weir wetland outlet structure.

Weir structures are mechanical or constructed barriers that span open drainage ditches. They allow wetland discharges to flow over a fixed crest or vertical wall down to a stable outlet near the base of the structure. Weir structures are constructed with steel, vinyl, or other composite piling material or are cast in place as a reinforced concrete drop structure.

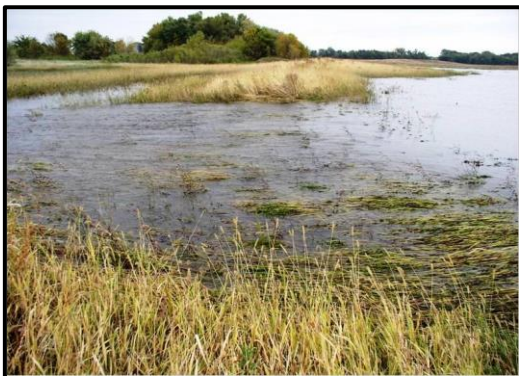
Vegetated spillway after a large runoff event.

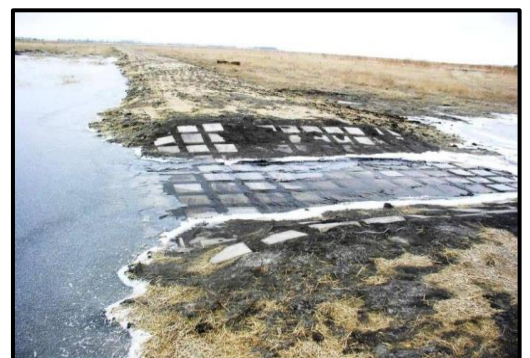
Manufactured concrete block armored spillway.

Rock riprap is the most common material used when constructing these types of spillways. Other materials may include concrete or engineered synthetic products.

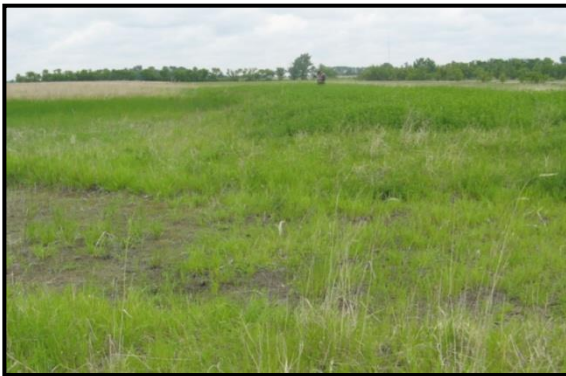
Example of a vegetated spillway that has sparse vegetation but no scouring. Reseeding is likely necessary - condition score 2.

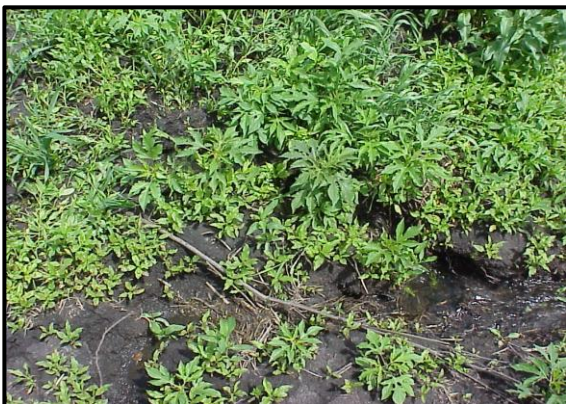
Example of a vegetated spillway that has excessive weed growth and is starting to scour. Repair is necessary - condition score 3.

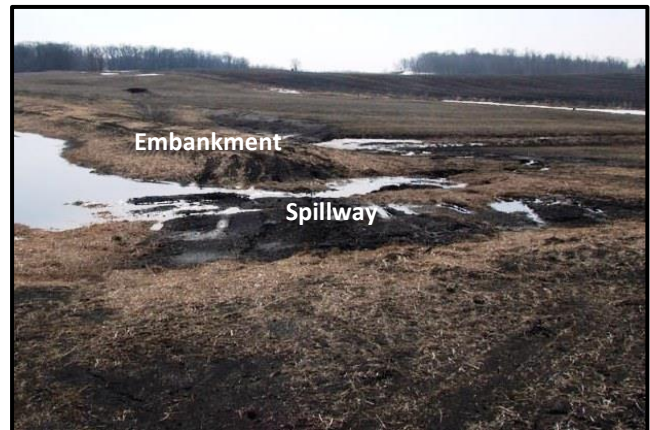
Example of a poorly graded vegetated spillway. Note concentration of flowing water along edge of embankment. Repair is likely needed – condition score 3.

Scouring of vegetated spillways often occurs when the spillway has a poor stand of vegetation, is poorly graded and water ponds within its control section, or when it experiences flows that are just too high or long in duration. Evidence of this will be an eroded channel through the spillway's control section.

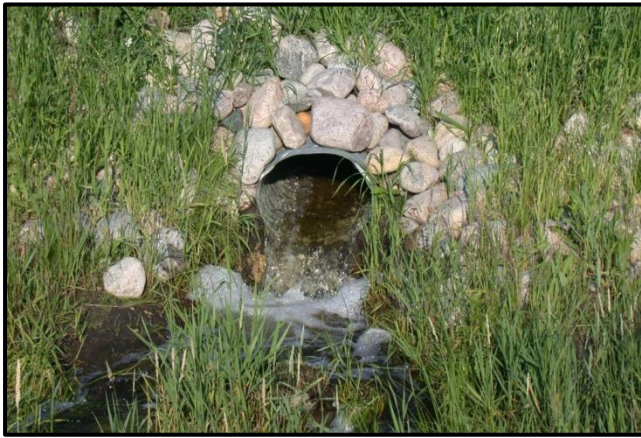
Example of a minor scouring at pipe outlet - condition score 2.

Scouring can occur with other outlet structures, typically at inlets and outlets where flows and turbulence are the greatest. Pay close attention and determine if scouring has displaced extensive soil in these areas. If rock riprap or other armor material exists, determine if scouring and erosion of the underlying soils has displaced the rock riprap material and if additional riprap may be needed.

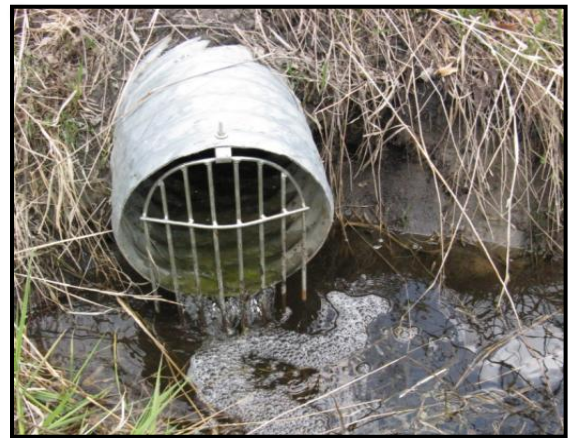
Example of more severe scouring at pipe outlet. Repair is likely necessary - condition score 3.

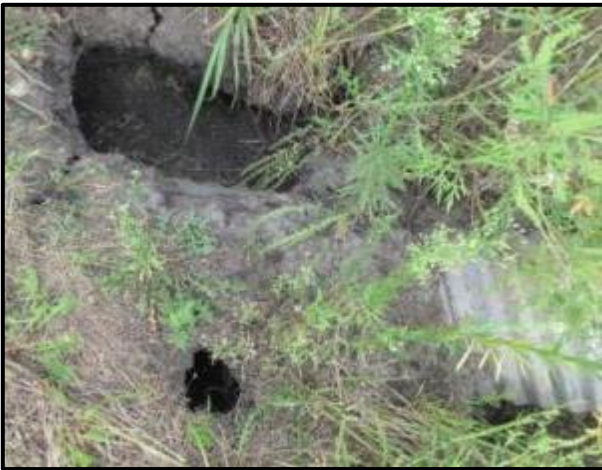
Evidence of settling or erosion along installed conduit. Repair is necessary – condition score 4.

Erosion can also occur in areas that are more difficult to detect. Outlet structures placed through embankments are subject to erosion of internal compacted soils along their length. This type of erosion often occurs along the outside surface of installed structures, in particular pipes or conduits. It can also occur around or under the outside edges of other structures such as weirs or armored spillways. While design and construction measures may have been taken to prevent this, it may still occur, often due to poor soil placement and compaction along these structures. To detect this, there may be obvious indicators such as partial or complete loss of compacted fills around or under the outlet. Less obvious indicators will be small flows that are occurring under or along the outside edges including the downstream end of installed conduits. This condition will be easier to detect if there are no normal discharges occurring through the pipe or structure. This type of erosion, if not corrected, can lead to more serious problems such as complete failure of the structure.

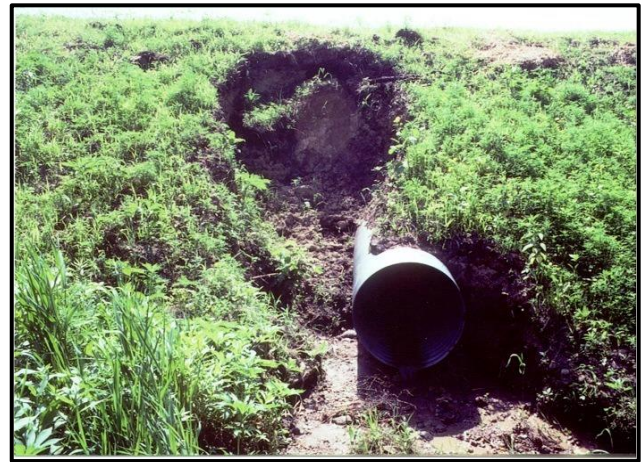
Severe erosion of internal embankment soils along installed conduit. Repair is necessary – condition score 4.

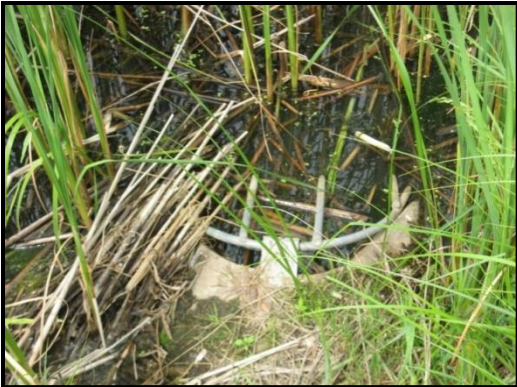
Outlet is overgrown with wetland vegetation. Maintenance is necessary – condition score 2.

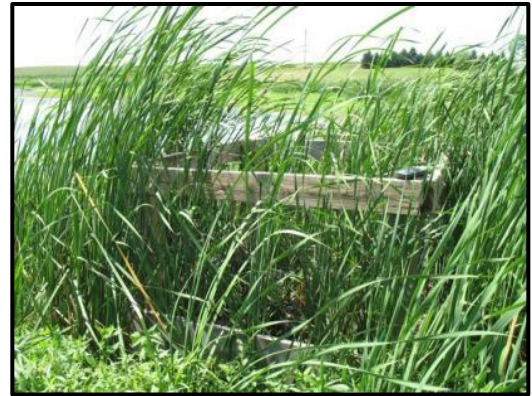
Outlet is overgrown with wetland vegetation. Maintenance is necessary – condition score 2.

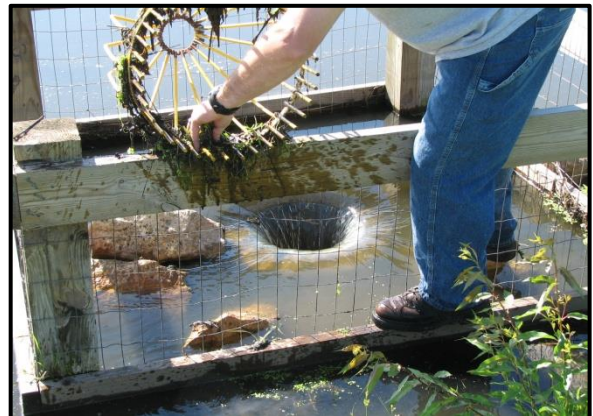
Trash guard being cleared of vegetation and debris.

Many pipe structures will incorporate a trash rack or guard of some type that frequently needs to be cleared of vegetation and other debris. Other structures will utilize skimmer systems or other devices to prevent debris from entering the structure. These occasionally need to be cleaned and cleared of debris as well. Fortunately, most observed blockages can be simply corrected when inspecting the site. This includes safely removing trash or other debris that has collected around, on top, or in front of the structure's entrances or exits. Be sure to document when and where blockages were found and cleared as part the site inspection.

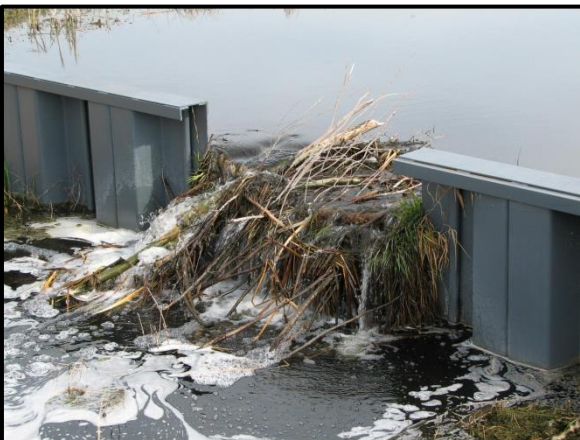
Weir structure plugged by beaver. Repair is necessary – condition score 4.

Certain blockages will be more difficult to detect or correct. These can include situations where beaver have plugged a structure, sediment has accumulated around an inlet or outlet of a structure, or when a piped structure has some type of internal blockage. When inspecting a pipe structure, try to determine if the pipe is free and clear of debris. One indication of a potentially plugged structure is if it is partially or fully submerged with little to no observed water flowing through or into it. Document the extent and cause of blockage, if known, when performing the site inspection.

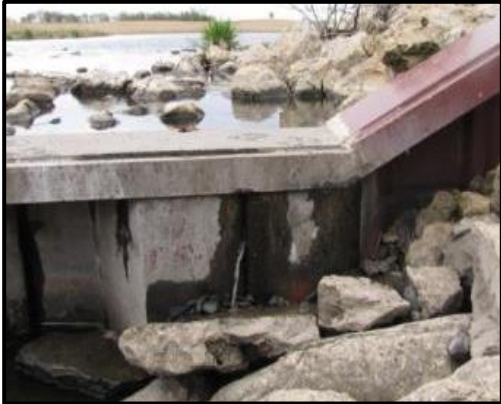
Vertical seam in sheet pile weir structure has minor leak. Needs monitoring – condition score 1.

Leaks are difficult to detect when water is discharging through or over a structure. They are best located when no water is entering the structure and leaks can be visibly seen or heard within it. A leak may also be suspected if no wetland flows are entering a structure yet discharges are observed at its outlet. If a leak is detected or suspected, attempt to identify and document its source.

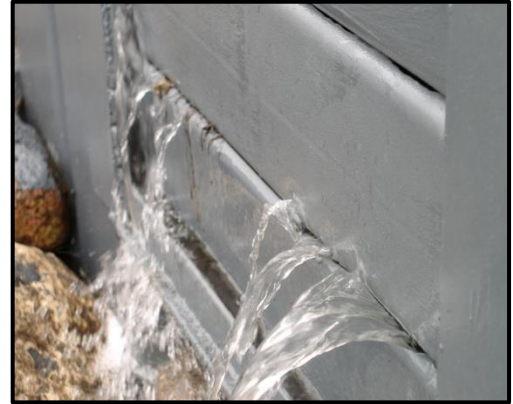
Stoplog seams are leaking. Maintenance or repair will be necessary – condition score 2.

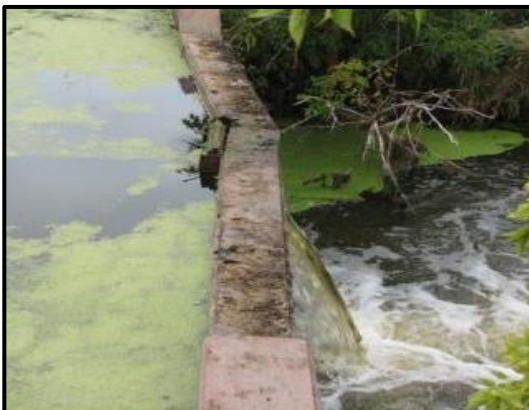
Weir structure appears to be failing. Repair will be necessary – condition score 4.

In addition to natural products such as rock riprap, other materials used in the construction of wetland outlets include plastic, vinyl, metal, and concrete products. These materials will show wear and tear over time, and eventually may need repair or replacement. Thoroughly inspect outlets and make note of any signs of wear or deterioration. Some indicators are fissures, flaking, cracks, rust, and unexpected discoloration.

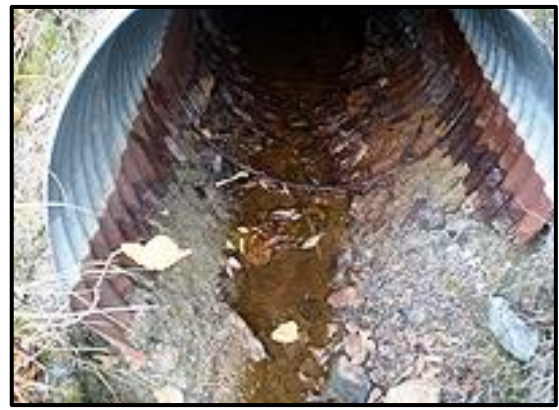
Culvert that has completely rusted through. Repair is necessary - condition score 4.

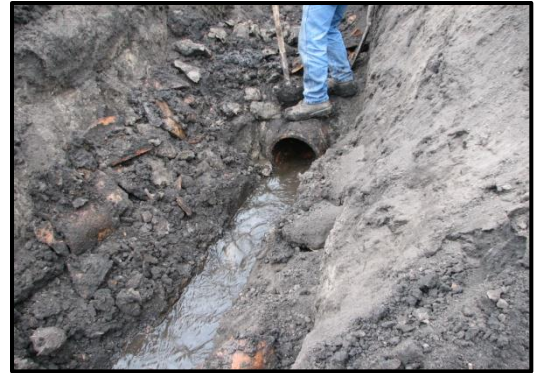
Removing a section of tile to install a tile block.

The location and number of tile blocks needed, length of tile to be removed, methods to seal the tile ends, and methods to backfill and compact the excavated trench are the essential design and construction elements of this restoration strategy. If not done properly, issues with settling, erosion, and wetland leakage may result. It is most important to look for problems when tile blocks are constructed under embankments or through areas where overground flow occurs such as through a vegetated spillway.

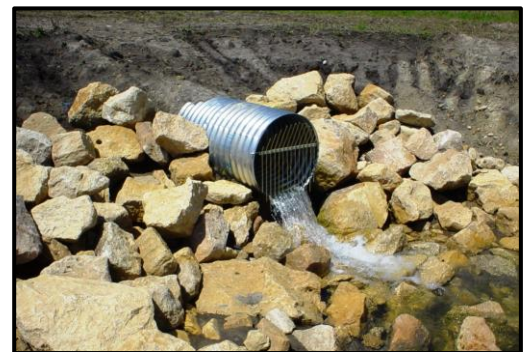
Constructed tile outlet (CMP) with rodent guard and rock riprap.

The tile outlet should be well protected to safely accommodate discharges from the upstream drainage system. The outlet will likely include a short sleeve of corrugated metal pipe (CMP) with a hinged rodent guard attached to it. It may also include a small amount of rock riprap to prevent scouring.

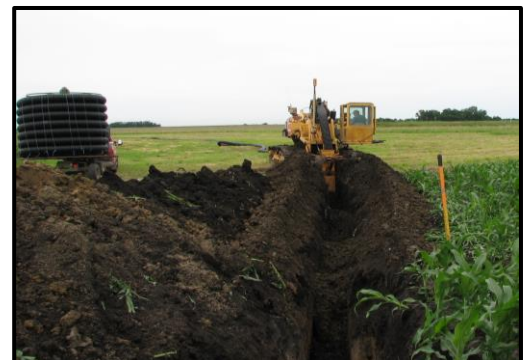
Installing subsurface drain tile to re-route a tileline.

Restoration construction may have included the re-routing of upstream drainage systems around or away from the restored wetland. This re-routing could be subsurface drainage tile or, in some cases, an open ditch system. These components only need inspection when located within the easement boundary. If they were installed on adjacent lands, it will typically be the responsibility of that neighboring landowner to maintain their part of the re-routed drainage system.

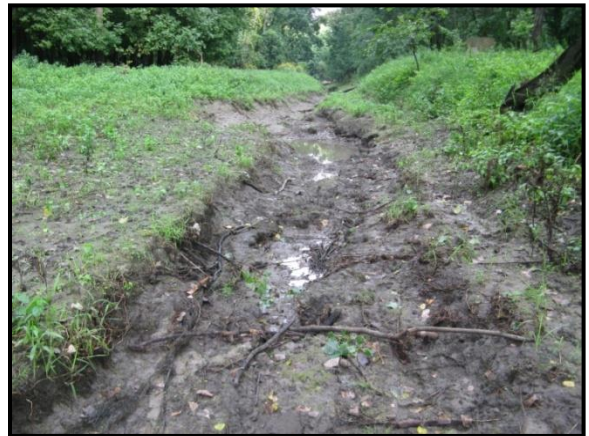
Significant scouring of a constructed overflow channel. Repair is necessary – condition score 4.

Also look for signs of head-cutting or sloughing of side slopes when inspecting constructed channels or ditches.

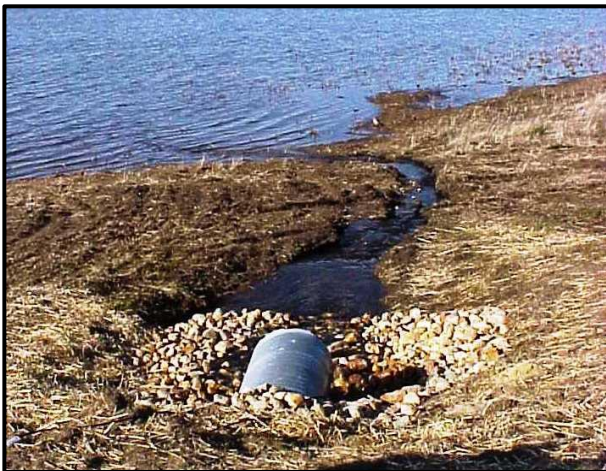
Minor erosion occurring between constructed tile outlet and restored wetland. Repair may be needed – condition score 2.

Erosion and scouring can occur at tile outlets, over areas where tile blocks have been constructed, or at areas where drainage systems have been diverted or re-routed. Pay close attention to these areas and look for signs of erosion, scouring, channeling, etc.

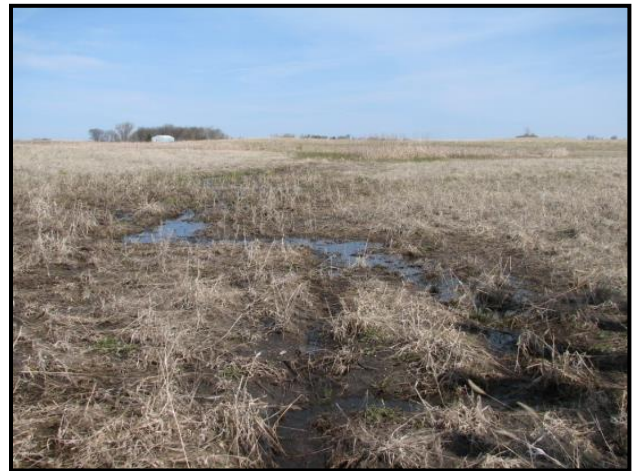
Channelized flow occurring through spillway area where a tile block was performed. Excessive settling within the tile removal trench has channelized flow and caused some scouring. Repair may be necessary – condition score 3.

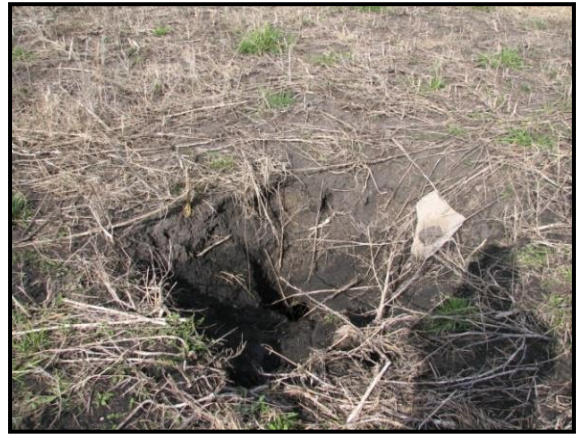
A failed plug at downstream end of a constructed tile block. Downstream tile is pulling sediment into it, forming a sinkhole. Repair is necessary – condition score 4.

At locations where tile blocks were constructed or where a junction with an existing tile system was made, a potential exists for the block or junction to fail. This results in surface soils and possibly even wetland hydrology entering the functioning downstream tile system. If not repaired, bigger issues with sedimentation and plugging of the downstream tile system will result.

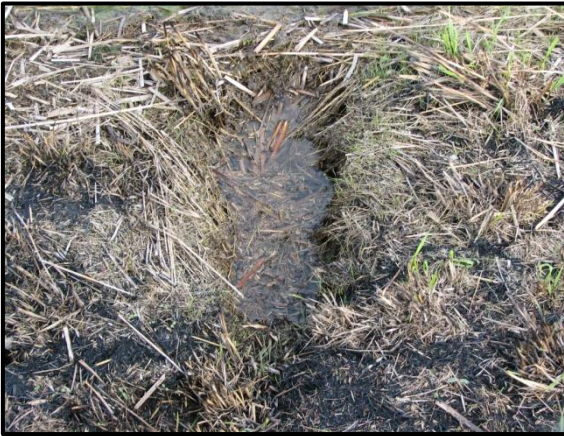
Settlement of soils within tile removal trench allowing water to pond. Repair recommended – condition score 3.

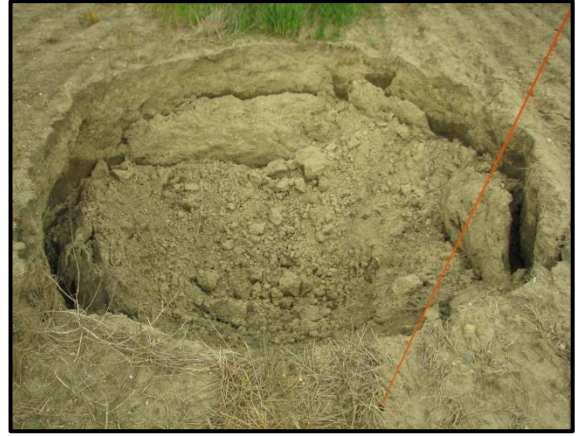
A failed tile joint on a re-routed tile system. The downstream tile is pulling sediment into it, forming a sinkhole. Repair is necessary – condition score 4.

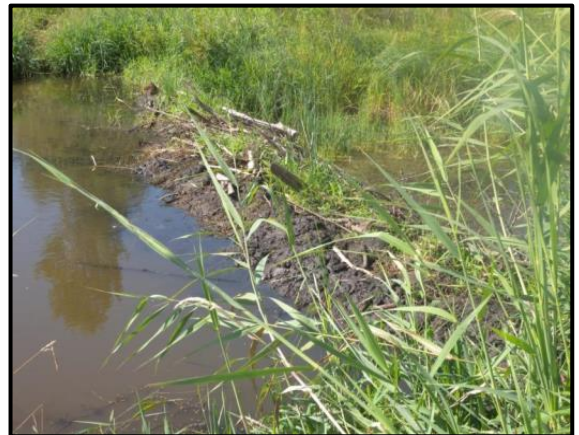
A beaver dam constructed across diversion ditch. Repair is necessary - condition score 4.

Both existing as well as constructed channels and ditches can be compromised by beaver dams. Inspect for presence of beaver and beaver dams at all locations where channels, swales, or ditches exist.
